## **LX2000/LX1000 Vacuum Tube Maintenance Kit and Ink Pad Replacement**

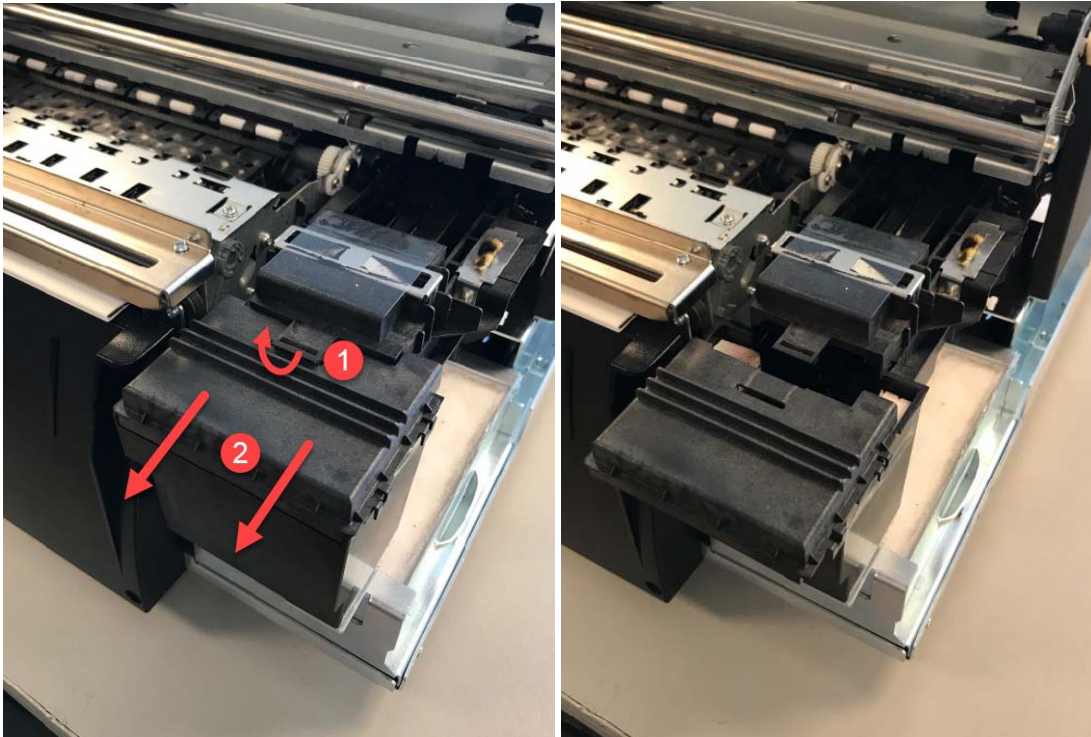
1. Open the Cover
2. Locate the black Ink capture bin.
3. Lift the latch (1) and pull the cover forward (2).

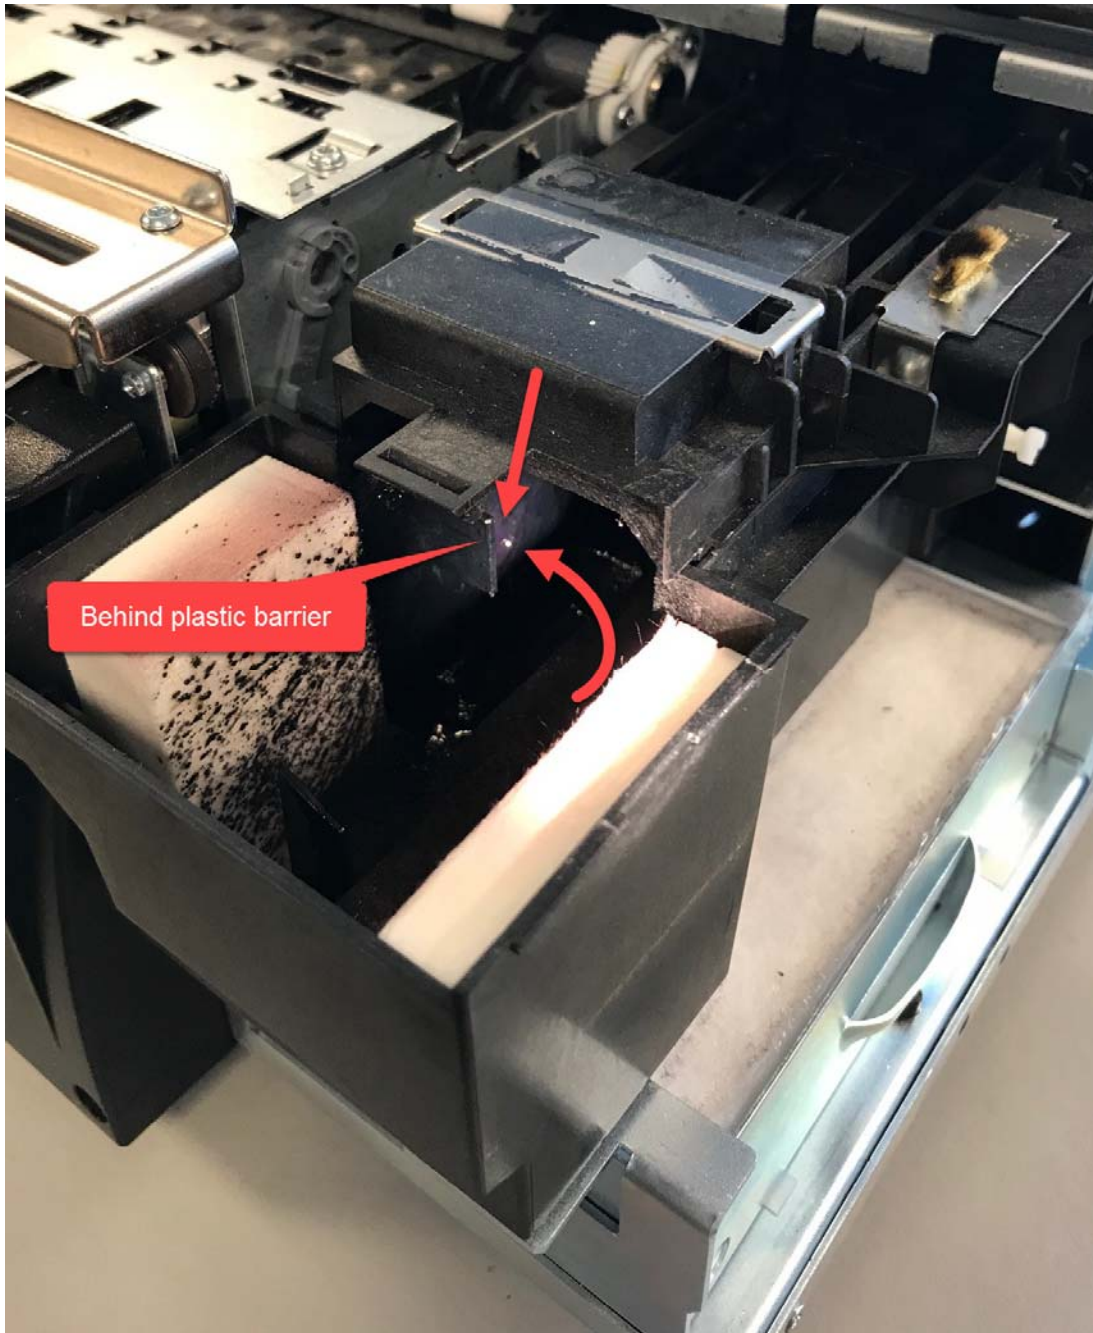
4. Look for the tube opening behind the small plastic barrier. You may need to use a flash light to see the opening.

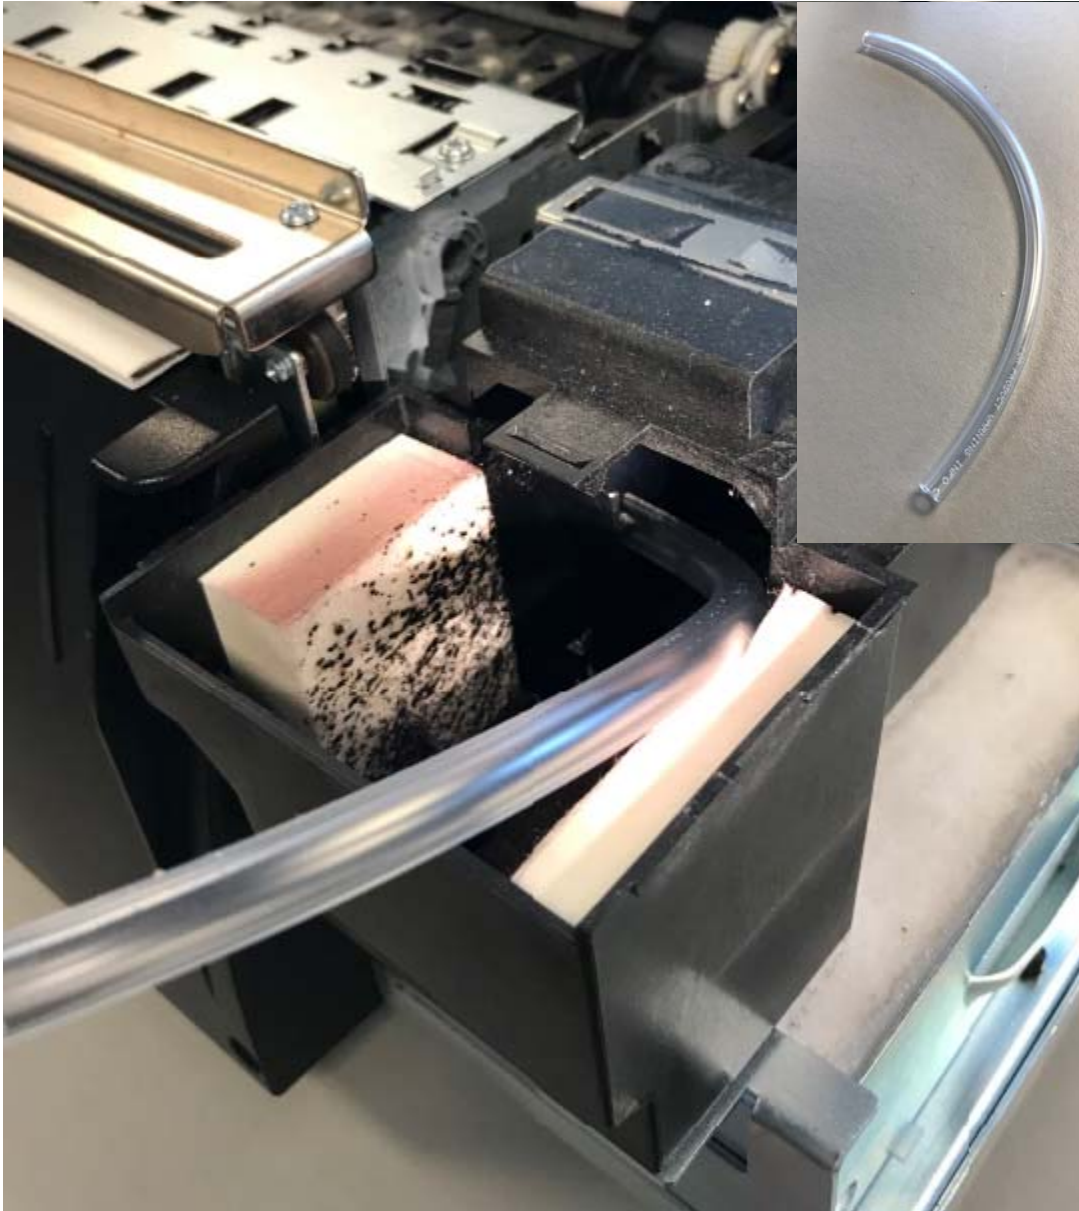
5. Locate the clear tube included with the kit. The tube is just small enough to fit inside the vacuum tube. **Tip!** Use rubber gloves for this part.

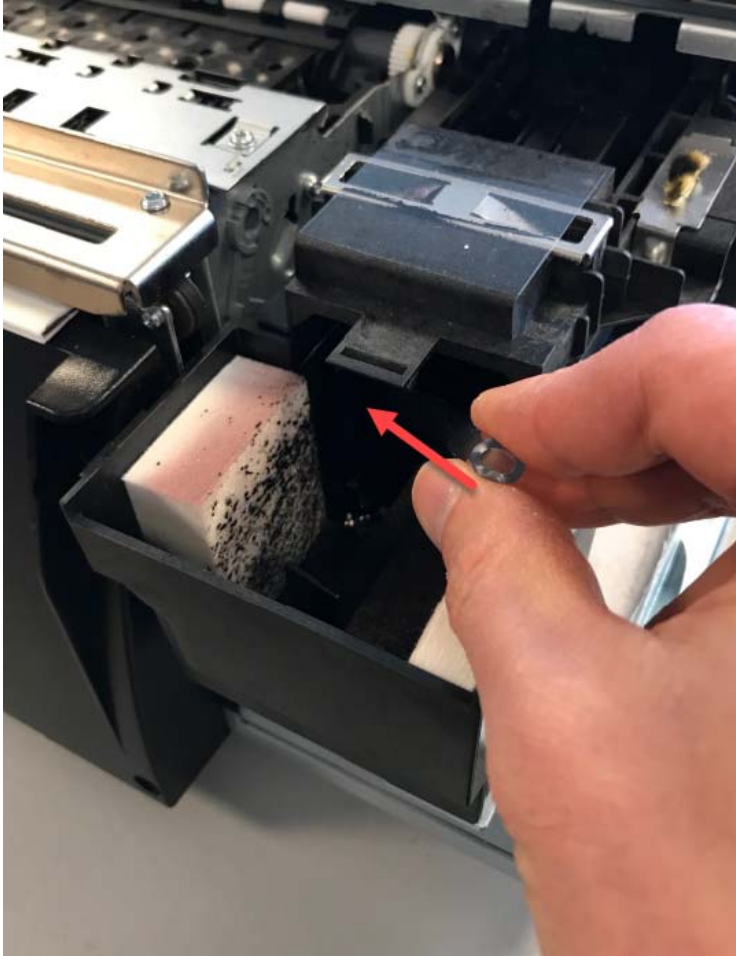
6. Push the tube as far as you can while still holding it with your fingers.

7. Remove the tube. It should be full of black ink. One cleaning is usually enough. However, you may wash the tube and repeat the cleaning immediately, save the tube for repeat use or discard it after use.
8. Replace the Ink Capture Bin Cover.
9. Finally replace the ink pad saturation tray by pushing down on the release pin and pulling the drawer out.

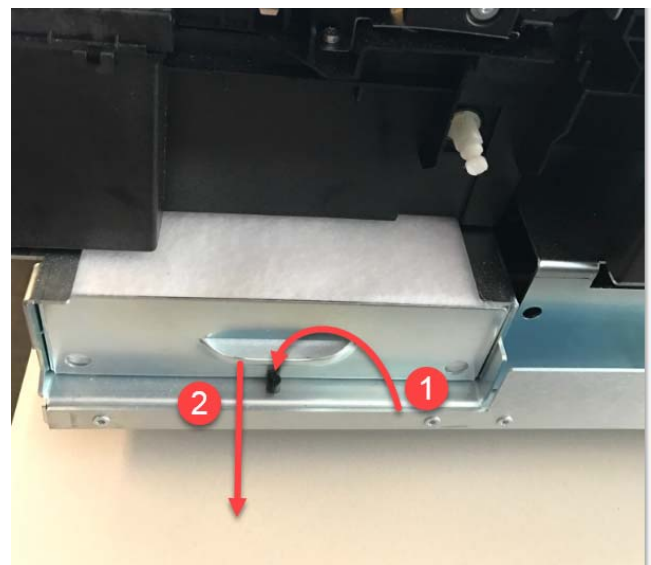
**Note:** The new tray has only 2 saturation pads instead of 3. This was done to prevent blockage of drain holes inside the capture bin.
